2009

Muddy Brook and Little River Water Quality Improvement Plan

Prepared by the
Eastern Connecticut
Conservation District, Inc.

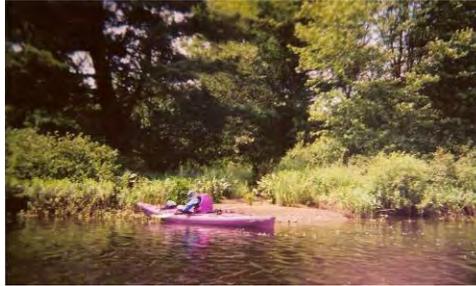
2006 Sediment plume in Shepherd's Pond

that a fine sediment deposit extended into the west shore of Shepherd's Pond. In October 2005, there was a significant flood event northeastern CT. It is unknown if the sediment deposit existed prior to October 2005. The sediment deposit should be monitored. ECCD staff was unable to determine if any of the drainage channels from Little Pond Road led to this sediment deposit.

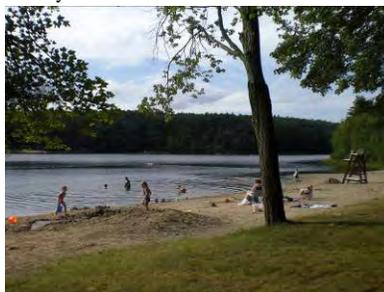
Muddy Pond Beach

Muddy Pond and the headwater region of Muddy Brook upstream of the Moss Brook convergence are not demonstrating water any quality issues. Muddy Pond is a State Designated Swimming Area. The Town of Woodstock owns and operates a public bathing beach at Muddy Pond, and the water is tested on a biweekly basis for E. coli in the summer season. The past seven years of E. coli monitoring

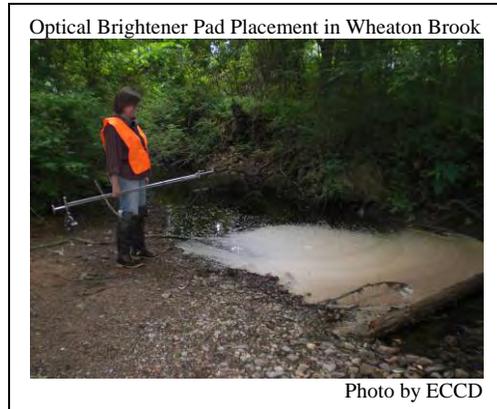
Optical Brightener Pad Placement in Wheaton Brook

Most homes and business are required to be connected to the public sewer system in this part of Putnam, with the notable exception of the Putnam Armory located on Wicker Street as previously noted. ECCD staff deployed two optical brightener pads in Wheaton Brook and results were negative.
